**Flood Control Project Maintenance
Levee Inspections**

Fall 2018 Levee Maintenance Deficiency Summary Report

**Flood Control Project Maintenance
Levee Inspections**
LMA District Cover Sheet
Fall 2018 Levee Inspection Results

Reclamation District No. 2060 Hastings

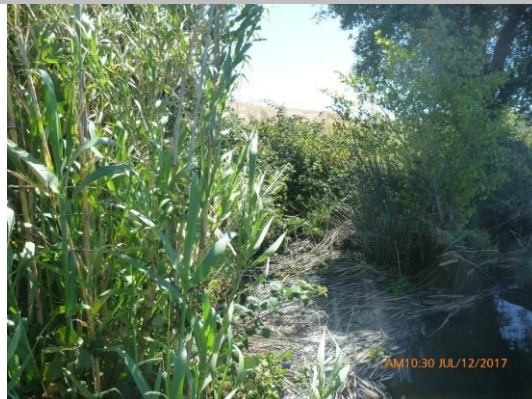
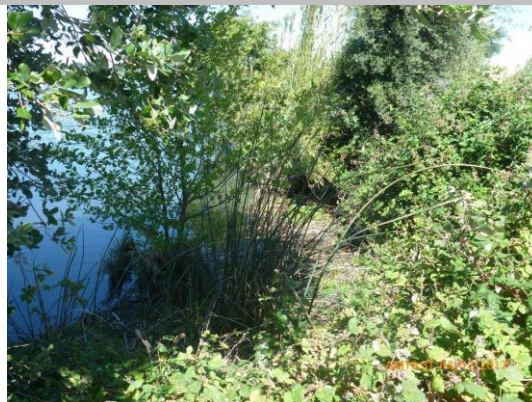
LM Start	0.40	Rating **	M	Issue No.	5 (cont)	
LM End	0.40	Issue Type +	Ma	Location *	WS	
Category	Supplemental			GPS Latitude/Longitude		
				Start		End
Item	2017 Storm Damage			38.247894 °		38.247911 °
				-121.703492 °		-121.703539 °
DWR ID	DWR_RD2060_01_f _ 2017_5					
Comment Code						
Inspector Comment						
Levee Evaluation Comments						
Description:Erosion commences approximately 3/4 of the way down the slope, near the water line towards the waterside toe.						
Site ID No:358						
Site Designation:LMA-185						
Repair Type: Erosion						
Rating:Area of Concern						
Field Date:7/12/2017						
Notes: Small erosion into bank.

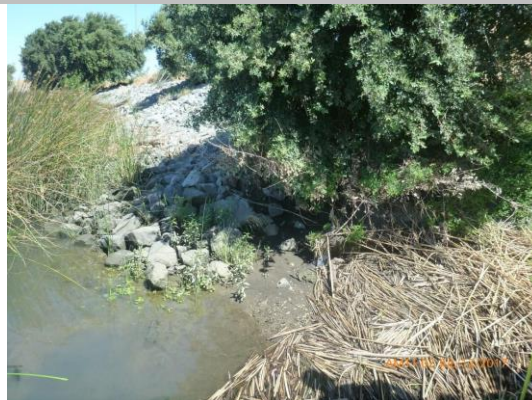
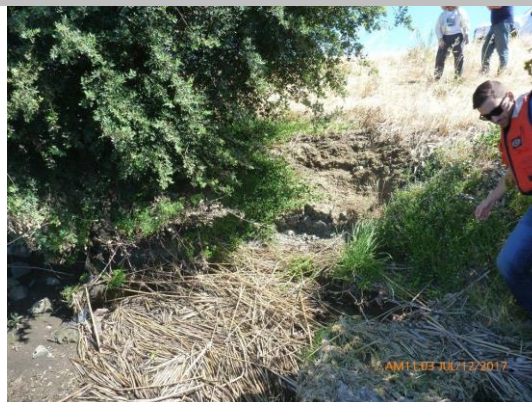
LM Start	0.41	Rating **	M	Issue No.	8 (cont)
LM End	0.42	Issue Type +	Ma	Location *	WS

LM Start	0.41	Rating **	M	Issue No.	8
LM End	0.42	Issue Type +	Ma	Location *	WS
Category	Supplemental			GPS Latitude/Longitude	
				Start	End
Item	2017 Storm Damage			38.248036°	38.248017°
				-121.703539°	-121.703789°
DWR ID	DWR_RD2060_01_f_2017_8				
Comment Code

Repair Type: Erosion

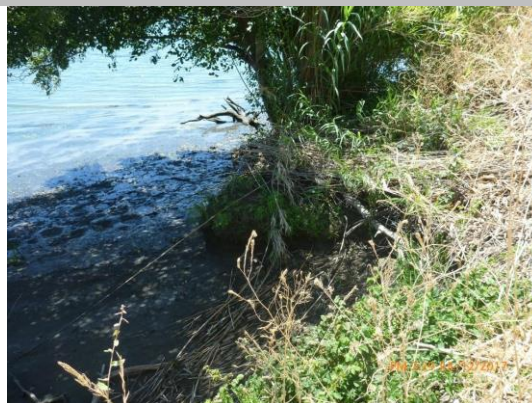
Photo 1 of 3 : FA_2018_RD2060_241_20_20180925_00026.jpg

LM Start	1.39	Rating **	A/W	Issue No.	20
LM End	1.56	Issue Type +	Ma	Location *	WS
Category	Supplemental		GPS Latitude/Longitude		
			Start	End	
Item	2017 Storm Damage		38.251886°	38.252619°	
			-121.719933°	-121.722842°	
DWR ID	DWR_RD2060_01_f_2017_20				
Comment Code					
Inspector Comment					
Levee Evaluation Comments Description: Erosion commences approximately halfway down the water side slope extending to the toe. Site ID No: 365 Site Designation: LMA-192 Repair Type: Erosion Rating: Serious Field Date: 7/12/2017 Notes: Several deep narrow cuts into levee, but mostly minor erosion at highwater line.

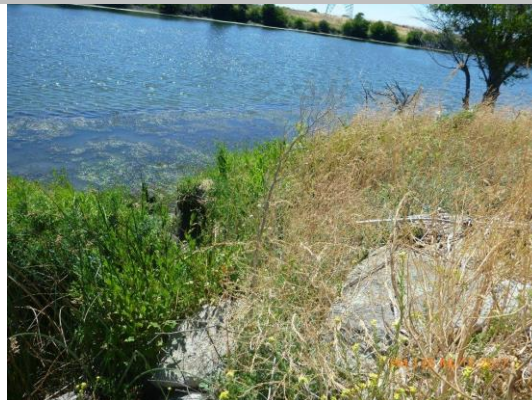
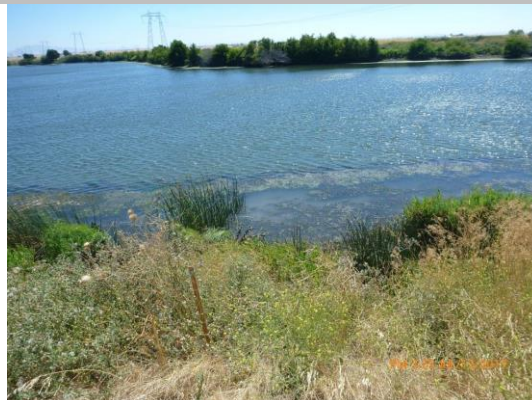
LM Start	1.81	Rating **	A/W	Issue No.	21 (cont)
LM End	1.84	Issue Type +	Ma	Location *	WS

LM Start	1.81	Rating **	A/W	Issue No.	21
LM End	1.84	Issue Type +	Ma	Location *	WS
Category	Supplemental			GPS Latitude/Longitude	
				Start	End
Item	2017 Storm Damage			38.255972 °	38.256247 °
				-121.724197 °	-121.724464 °
DWR ID	DWR_RD2060_01_f_2017_21				
Comment Code					
Inspector Comment					
Levee Evaluation Comments					
Description:Erosion commences approximately halfway down the water side slope extending to the toe. Some slipping into the toe has occurred due to deep erosion.					
Site ID No:366					
Site Designation:LMA-193					
Repair Type: Erosion					
Rating:Serious					
Field Date:7/12/2017					
Notes: Erosion extends halfway into the slope.

Repair Type: Erosion

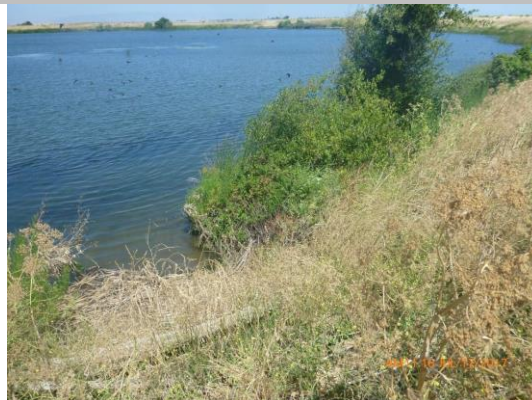
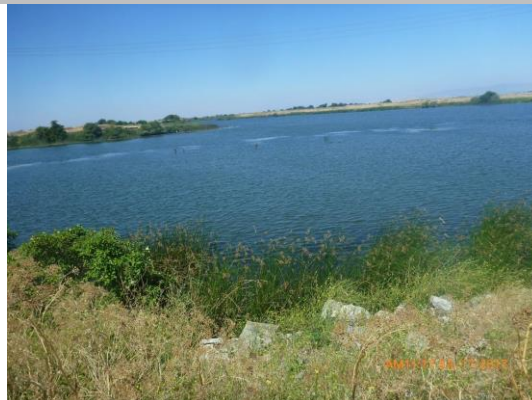
LM Start	1.90	Rating **	M	Issue No.	22 (cont)
LM End	1.95	Issue Type +	Ma	Location *	WS

Notes: Minor cracking observed below the hinge point and minor erosion at levee toe.

Repair Type: Erosion

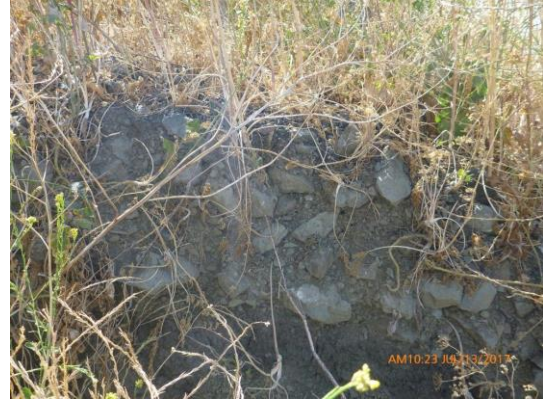
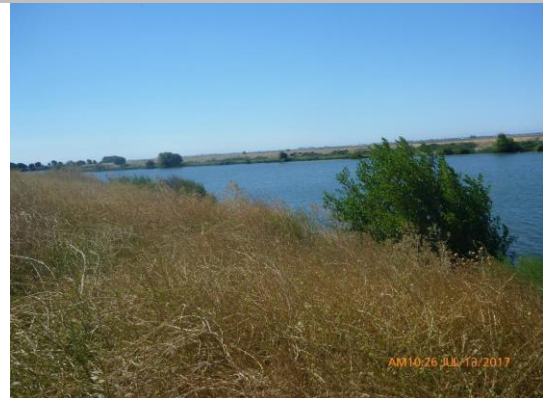
LM Start	2.10	Rating **	A/W	Issue No.	23 (cont)
LM End	2.13	Issue Type +	Ma	Location *	
Category	Supplemental			GPS Latitude/Longitude	
				Start	End
Item	2017 Storm Damage			38.259317 °	38.259258 °
				-121.726314 °	-121.726939 °
DWR ID	DWR_RD2060_01_f _ 2017_23				
Comment Code					
Inspector Comment					
Levee Evaluation Comments					
Description:Erosion commences approximately halfway down the water side slope extending to the rip rap.					
Site ID No:368					
Site Designation:LMA-195					
Repair Type: Erosion					
Rating:Serious					
Field Date:7/13/2017					
Notes: Erosion appears to be previously repaired, but has failed again.

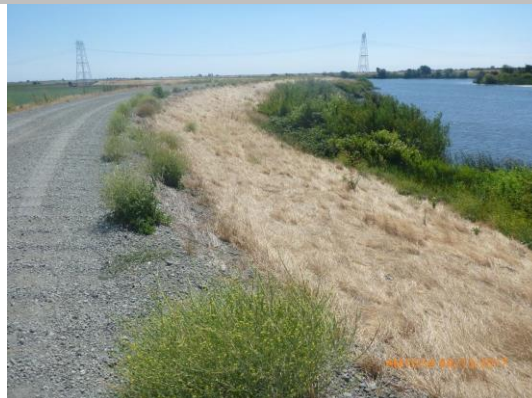
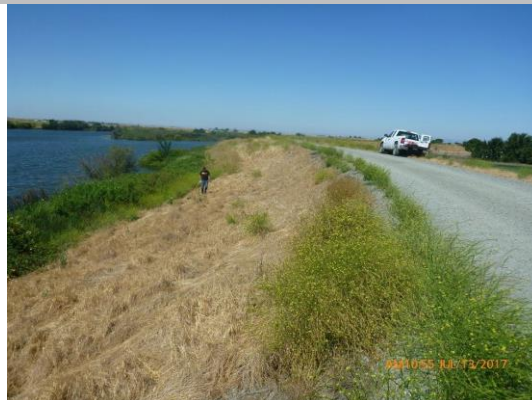
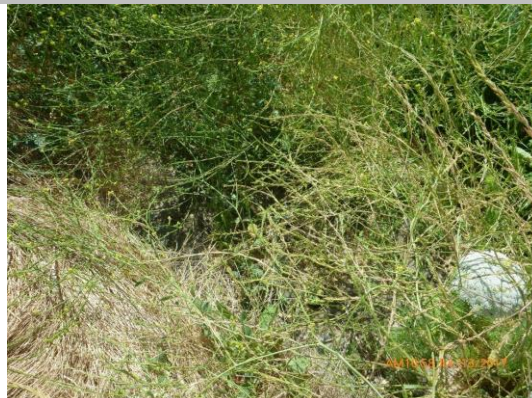
LM Start	2.57	Rating **	M	Issue No.	24 (cont)
LM End	2.60	Issue Type +	Ma	Location *	WS
Category	Supplemental			GPS Latitude/Longitude	
				Start	End
Item	2017 Storm Damage			38.257467 °	38.257286 °
				-121.734153 °	-121.734683 °
DWR ID	DWR_RD2060_01_f_2017_24				
Comment Code					
Inspector Comment					
Levee Evaluation Comments					
Description:Erosion commences approximately halfway down the water side slope. Part of the levee has sloughed down toward the waterline where further erosion occurs.					
Site ID No:369					
Site Designation:LMA-196					
Repair Type: Erosion					
Rating:Area of Concern					
Field Date:7/13/2017					
Notes: Levee slope is concave due slumping. Erosion at waterline.

Repair Type: Erosion

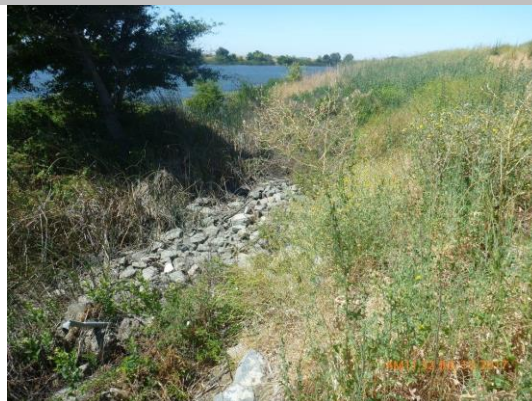
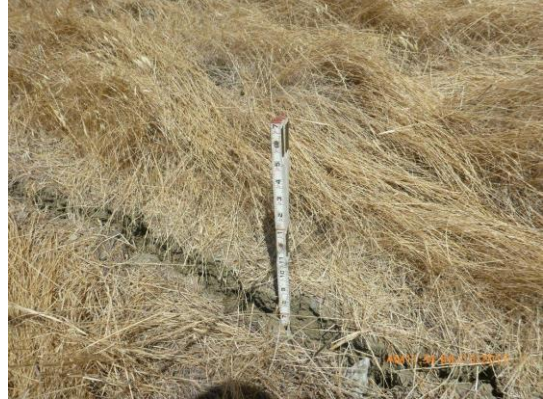
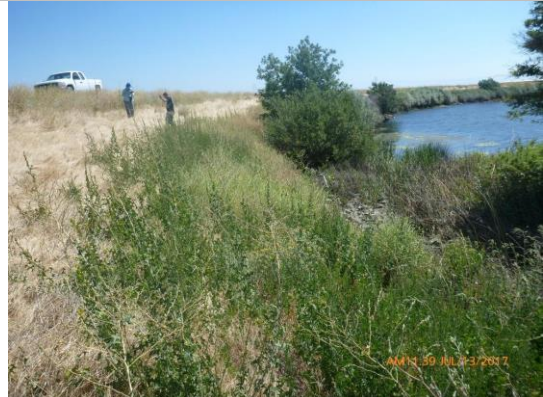
LM Start	3.07	Rating **	A/W	Issue No.	25
LM End	3.10	Issue Type +	Ma	Location *	
Category	Supplemental			GPS Latitude/Longitude	
				Start	End
Item	2017 Storm Damage			38.260772 °	38.260569 °
				-121.740817 °	-121.741194 °
DWR ID	DWR_RD2060_01_f_2017_25				
Comment Code					
Inspector Comment					
Levee Evaluation Comments					
Description:Erosion occurs near the waterline. Part of the levee has sloughed down toward the waterline due to erosion.					
Site ID No:370					
Site Designation:LMA-197					
Repair Type: Erosion					
Rating:Serious					
Field Date:7/13/2017					
Notes: Large erosion halfway into levee. Horizontal cracking on slope almost 24"deep.

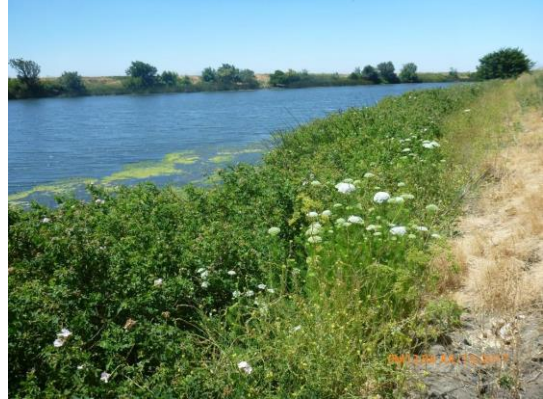
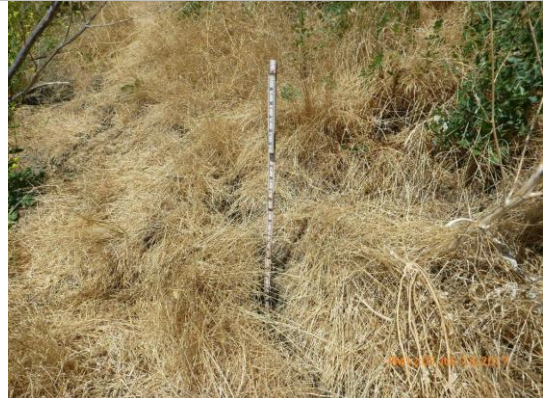
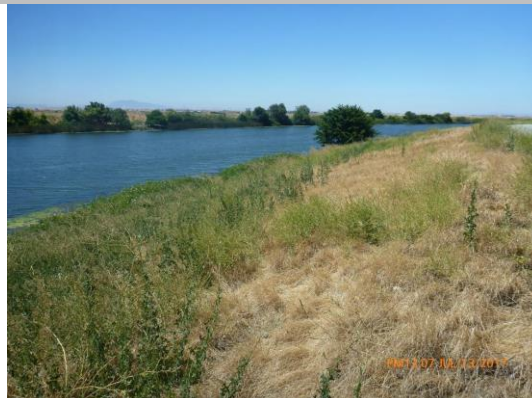
LM Start	3.17	Rating **	M	Issue No.	26
LM End	3.17	Issue Type +	Ma	Location *	
Category	Supplemental			GPS Latitude/Longitude	
				Start	End
Item	2017 Storm Damage			38.259925°	38.259903°
				-121.742236°	-121.742281°
DWR ID	DWR_RD2060_01_f_2017_26				
Comment Code					
Inspector Comment					
Levee Evaluation Comments					
Description:Erosion occurs near the waterline.					
Site ID No:371					
Site Designation:LMA-198					
Repair Type: Erosion					
Rating:Area of Concern					
Field Date:7/13/2017					
Notes: Minor erosion with sloughing. Horizontal cracks 3.5' deep.

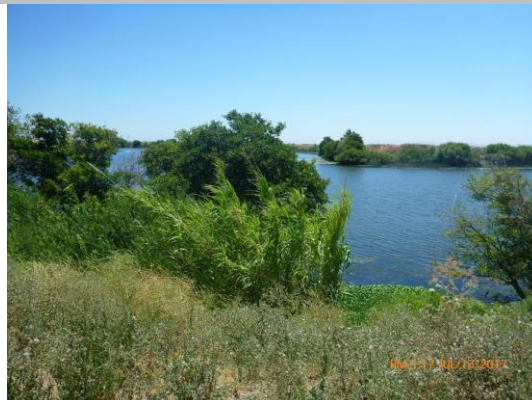
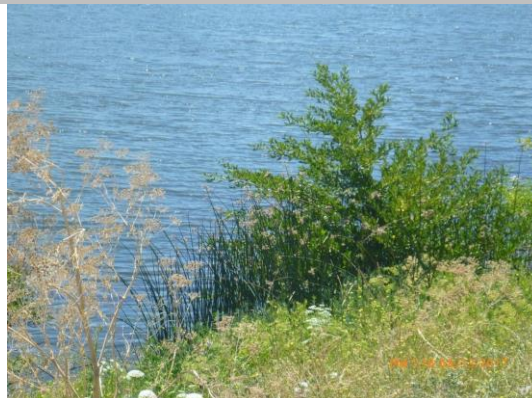
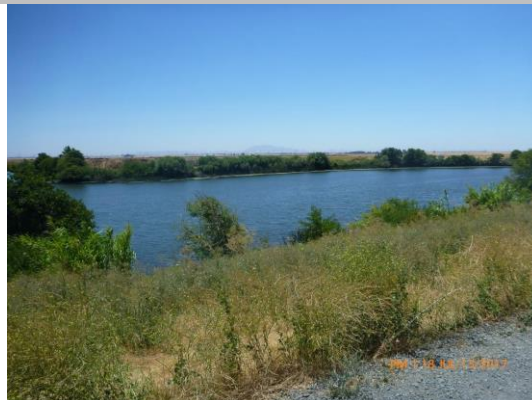
LM Start	3.60	Rating **	M	Issue No.	27
LM End	3.61	Issue Type +	Ma	Location *	
Category	Supplemental			GPS Latitude/Longitude	
				Start	End
Item	2017 Storm Damage			38.261469 °	38.261464 °
				-121.748389 °	-121.748442 °
DWR ID	DWR_RD2060_01_f_2017_27				
Comment Code					
Inspector Comment					
Levee Evaluation Comments					
Description:Erosion commences halfway down the slope and extends to the toe. Erosion is concentrated at the water line.					
Site ID No:373					
Site Designation:LMA-200					
Repair Type: Erosion					
Rating:Area of Concern					
Field Date:7/13/2017					
Notes: Small erosion with a narrow deep cut. Heavy veg is protecting the slope.

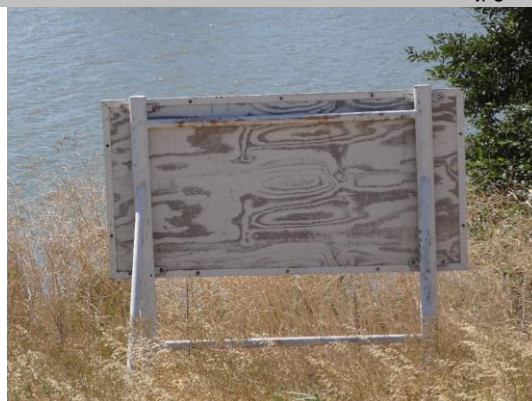
Photo 1 of 2 : UCIP_FA_2018_41908_30541.jpg

Comment Code						
Inspector Comment						
FS_ID:41908 DS_ID:22050 EP_NO: 10119 Repair Type: Non-Urgent Crossing Status: Indicator Found UCIP Comments: 09/19/2018 Updated record to reflect correct permit, historic levee log showed Permit No. 10119 correct Permit No. is 12784. Permit No. 10119 was issued for overhead lines. (O. Magana - DWR UCIP) 08/15/2013 Need to contact owner and verify status of crossing. (P. Amatya - DWR UCIP) FIELD_STRUCT_DESC: 8.625-inch steel natural gas pipeline through the levee, at an unknown depth. Gas line marker on the landside (LS). Sign board on the waterside (WS). (8.625-inch pipeline installed across the channel and both levees of Lindsey Slough authorized under Permit No. 12784, 1979 - Pacific Gas and Electric Company [PG&E]; 8.625-inch line referenced incorrectly as part of Permit No. 10119, 1975 - PG&E, correct Permit No. is 12784). [Additional Reference(s): DWR Levee Log, 2005]. FS Date: 8/15/2013

WS view: gasoline sign board on levee slope.

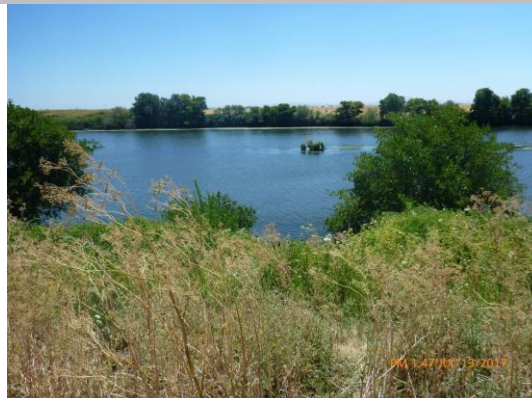
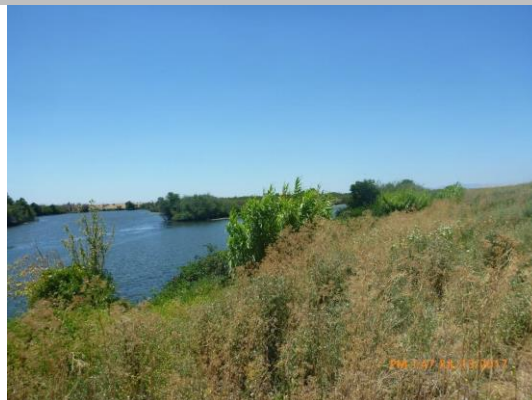
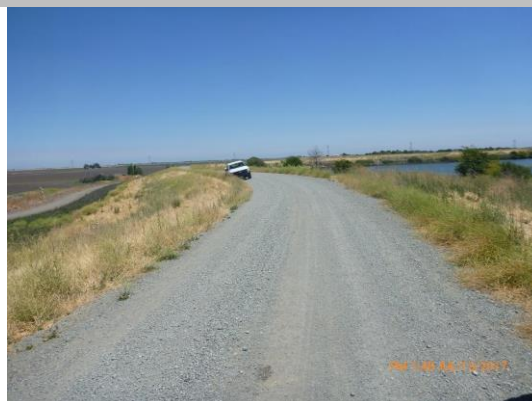
LM Start	3.67	Rating **	M	Issue No.	28
LM End	3.67	Issue Type +	Ma	Location *	
Category	Supplemental			GPS Latitude/Longitude	
				Start	End
Item	2017 Storm Damage			38.261181°	38.261167°
				-121.749542°	-121.749592°
DWR ID	DWR_RD2060_01_f _ 2017_28				
Comment Code					
Inspector Comment					
Levee Evaluation Comments					
Description:Erosion is concentrated near the water line.					
Site ID No:374					
Site Designation:LMA-201					
Repair Type: Erosion					
Rating:Area of Concern					
Field Date:7/13/2017					
Notes: Small narrow and deep cut. May have been caused by a collapsed beaver den.

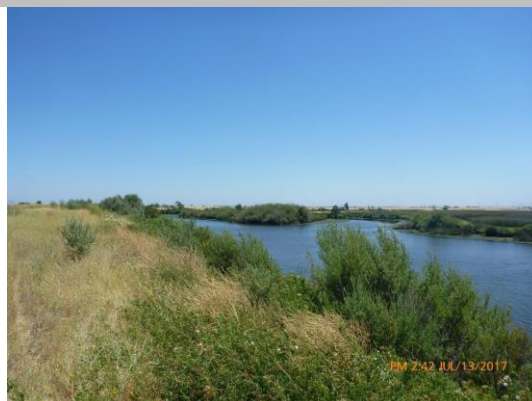
Photo 3 of 3 : FA_2018_RD2060_241_29_20180925_00055.jpg

LM Start	4.28	Rating **	A/W	Issue No.	29 (cont)	
LM End	4.28	Issue Type +	Ma	Location *		
Category	Supplemental			GPS Latitude/Longitude		
				Start	End	
Item	2017 Storm Damage			38.260992 °	38.261017 °	
				-121.759806 °	-121.759847 °	
DWR ID	DWR_RD2060_01_f_2017_29					
Comment Code						
Inspector Comment						
Levee Evaluation Comments						
Description:Erosion commences halfway down the slope and extends to the toe. Erosion is concentrated at the water line.						
Site ID No:376						
Site Designation:LMA-203						
Repair Type: Erosion						
Rating:Area of Concern						
Field Date:7/13/2017						
Notes: Could not get to erosion due to dense veg. Possibly a deep narrow cut.

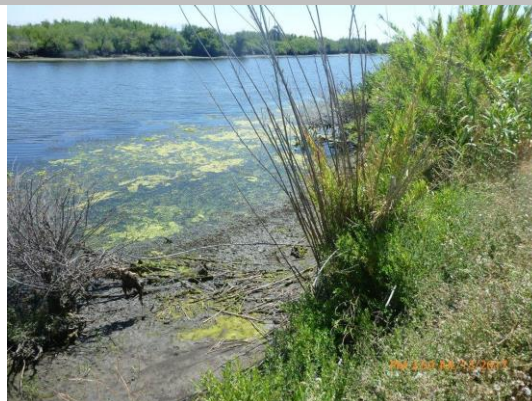
Photo 1 of 3 : FA_2018_RD2060_241_30_20180925_00056.jpg

LM Start	4.40	Rating **	M	Issue No.	30	
LM End	4.46	Issue Type +	Ma	Location *		
Category	Supplemental			GPS Latitude/Longitude		
				Start	End	
Item	2017 Storm Damage			38.260850 °	38.260425 °	
				-121.761875 °	-121.762861 °	
DWR ID	DWR_RD2060_01_f_2017_30					
Comment Code						
Inspector Comment						
Levee Evaluation Comments						
Description:Erosion/sloughing commences approximately halfway down the slope. Erosion is concentrated mostly near the water line and has resulting in slippage of the slope.						
Site ID No:377						
Site Designation:LMA-204						
Repair Type: Erosion						
Rating:Area of Concern						
Field Date:7/13/2017						
Notes: large cut is 100' of 320' site. Large cut is 12' vertical and the rest is 6'.

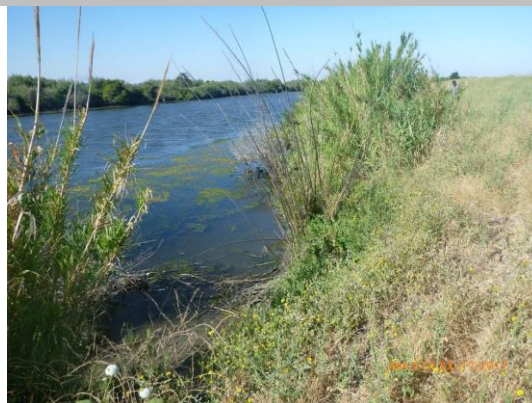
Photo 1 of 3 : FA_2018_RD2060_241_31_20180925_00059.jpg

LM Start	4.50	Rating **	A/W	Issue No.	31
LM End	4.53	Issue Type +	Ma	Location *	
Category	Supplemental			GPS Latitude/Longitude	
				Start	End
Item	2017 Storm Damage			38.260150 °	38.259939 °
				-121.763556 °	-121.764064 °
DWR ID	DWR_RD2060_01_f _ 2017_31				
Comment Code					
Inspector Comment					
Levee Evaluation Comments					
Description:Erosion commences approximately 3/4 of the way down the slope. It has resulted in some sloughing.					
Site ID No:378					
Site Designation:LMA-205					
Repair Type: Erosion					
Rating:Serious					
Field Date:7/17/2017					
Notes: Deep, wide, vertical cut into slope almost 1/2 way into sope.

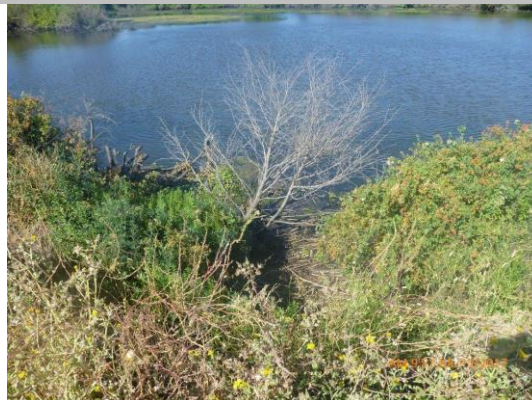
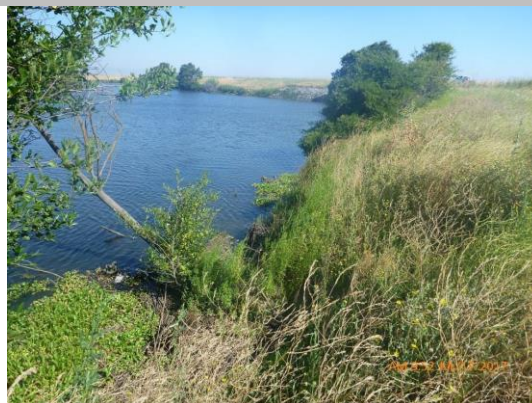
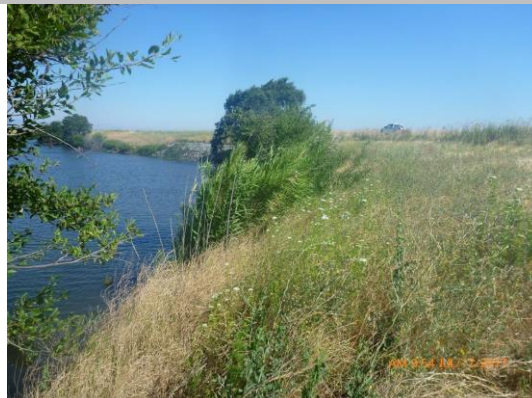
LM Start	4.80	Rating **	A/W	Issue No.	32
LM End	4.88	Issue Type +	Ma	Location *	
Category	Supplemental			GPS Latitude/Longitude	
				Start	End
Item	2017 Storm Damage			38.260714 °	38.261808 °
				-121.767972 °	-121.768536 °
DWR ID	DWR_RD2060_01_f_2017_32				
Comment Code					
Inspector Comment					
Levee Evaluation Comments					
Description:Erosion/sloughing commences approximately halfway down the slope. Erosion is concentrated mostly near the water line and has resulting in slippage of the slope towards the toe.					
Site ID No:379					
Site Designation:LMA-206					
Repair Type: Erosion					
Rating:Serious					
Field Date:7/17/2017					
Notes: Several erosions with slumping. Fresh soil indicates active erosion this season. Adjacent slope has riprap. Riprap should be extended along this stretch.

LM Start	4.80	Rating **	A/W	Issue No.	32 (cont)	
LM End	4.88	Issue Type +	Ma	Location *		
Category	Supplemental			GPS Latitude/Longitude		
				Start	End	
Item	2017 Storm Damage			38.260714 °	38.261808 °	
				-121.767972 °	-121.768536 °	
DWR ID	DWR_RD2060_01_f_2017_32					
Comment Code						
Inspector Comment						
Levee Evaluation Comments						
Description: Erosion/sloughing commences approximately halfway down the slope. Erosion is concentrated mostly near the water line and has resulting in slippage of the slope towards the toe.						
Site ID No: 379						
Site Designation: LMA-206						
Repair Type: Erosion						
Rating: Serious						
Field Date: 7/17/2017						
Notes: Several erosions with slumping. Fresh soil indicates active erosion this season. Adjacent slope has riprap. Riprap should be extended along this stretch.

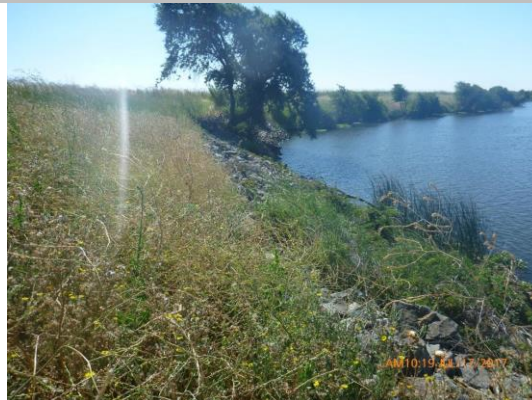
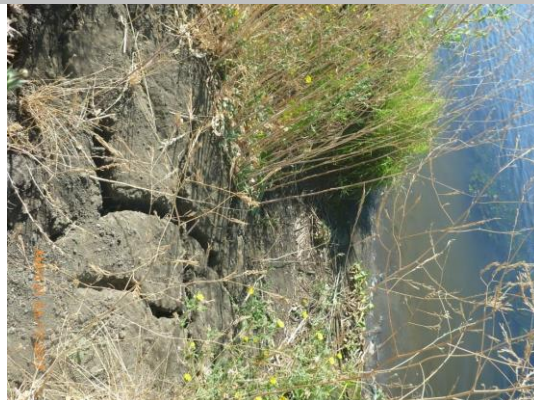
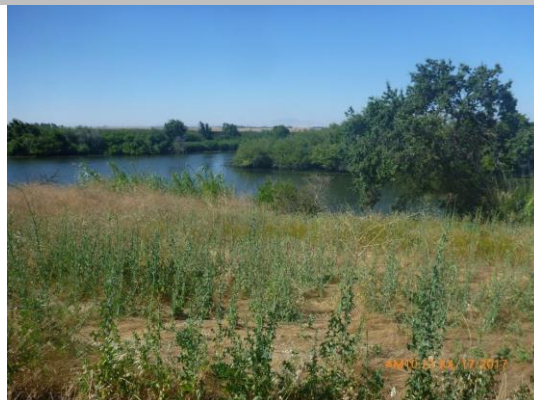
LM Start	4.92	Rating **	M	Issue No.	33
LM End	4.92	Issue Type +	Ma	Location *	
Category	Supplemental			GPS Latitude/Longitude	
				Start	End
Item	2017 Storm Damage			38.262128 °	38.262128 °
				-121.769175 °	-121.769175 °
DWR ID	DWR_RD2060_01_f_2017_33				
Comment Code					
Inspector Comment					
Levee Evaluation Comments					
Description:Erosion/sloughing commences approximately halfway down the slope. Erosion is concentrated mostly near the water line and has resulting in slippage of the slope into the toe.					
Site ID No:380					
Site Designation:LMA-207					
Repair Type: Erosion					
Rating:Area of Concern					
Field Date:7/17/2017					
Notes: Reduced length of site from 275 to 62. No widespread erosion, just 2 small erosions upstream from adjacent riprap.

LM Start	4.92	Rating **	M	Issue No.	33 (cont)	
LM End	4.92	Issue Type +	Ma	Location *		
Category	Supplemental			GPS Latitude/Longitude		
				Start	End	
Item	2017 Storm Damage			38.262128°	38.262128°	
				-121.769175°	-121.769175°	
DWR ID	DWR_RD2060_01_f_2017_33					
Comment Code						
Inspector Comment						
Levee Evaluation Comments						
Description:Erosion/sloughing commences approximately halfway down the slope. Erosion is concentrated mostly near the water line and has resulting in slippage of the slope into the toe.						
Site ID No:380						
Site Designation:LMA-207						
Repair Type: Erosion						
Rating:Area of Concern						
Field Date:7/17/2017						
Notes: Reduced length of site from 275 to 62. No widespread erosion, just 2 small erosions upstream from adjacent riprap.

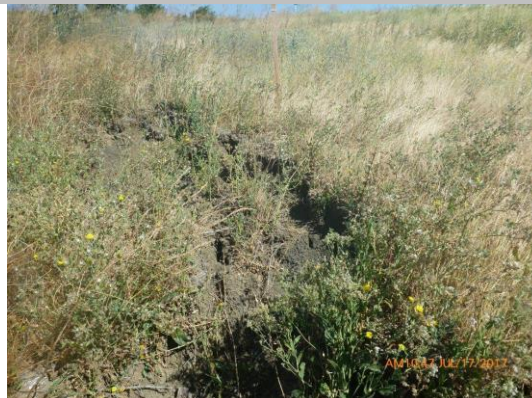
Photo 3 of 3 : FA_2018_RD2060_241_34_20180925_00070.jpg

LM Start	5.00	Rating **	M	Issue No.	34 (cont)	
LM End	5.01	Issue Type +	Ma	Location *		
Category	Supplemental			GPS Latitude/Longitude		
				Start	End	
Item	2017 Storm Damage			38.262636 °	38.262658 °	
				-121.770503 °	-121.770547 °	
DWR ID	DWR_RD2060_01_f_2017_34					
Comment Code						
Inspector Comment						
Levee Evaluation Comments						
Description:Erosion is concentrated mostly near the water line and has resulting in slippage of the slope into the toe.						
Site ID No:381						
Site Designation:LMA-208						
Repair Type: Erosion						
Rating:Area of Concern						
Field Date:7/17/2017						
Notes: Extended site from 15' to 75' to include LMA-209. Small erosions will become 1 site next high water due to sloughing between them.

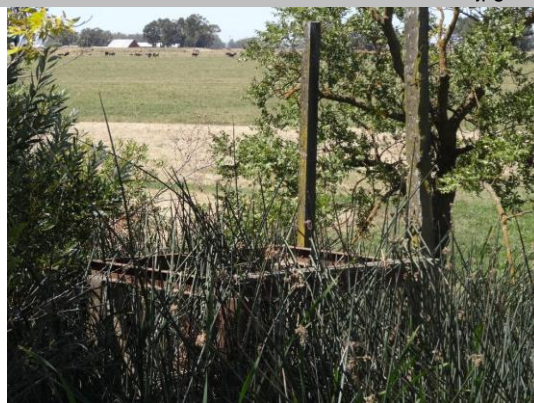
Photo 1 of 2 : UCIP_FA_2018_46769_31088.jpg

LM Start	0.00	Rating **	M	Issue No.	8	
LM End	0.00	Issue Type +	En	Location *		
Category	Supplemental			GPS Latitude/Longitude		
				Start	End	
Item	DWR UCIP Field Study			38.289474 °	38.289474 °	
				-121.775914 °	-121.775914 °	
DWR ID	22059					
Comment Code						
Inspector Comment						
FS_ID:46769 DS_ID:22059 EP_NO: N/A Repair Type: Non-Urgent Crossing Status: Indicator Found UCIP Comments: - Abandoned pump structure in stream needs proper abandonment- Not accessible due to wired fence FIELD_STRUCT_DESC: *ABANDONED* Pump structure in stream. Concrete distribution box on the landside (LS) slope. Not accessible due to a wire fence. [Additional Reference(s): DWR Levee Log, 2005]. FS Date: 8/15/2013

WS view: abandoned pump support in stream/channel. Not accessible due to vegetation.

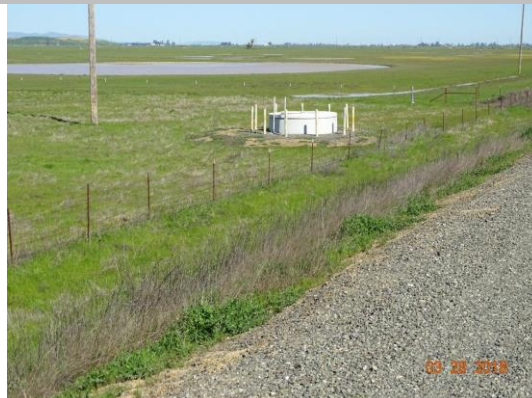
Photo 1 of 1 : FA_2018_RD2060_242_2_20180925_00001.jpg

LM Start	0.12	Rating **	M	Issue No.	2
LM End	1.78	Issue Type +	En	Location *	WS
Category	Earthen Levee			GPS Latitude/Longitude	
				Start	End
Item	Encroachments			38.276351°	38.285819°
				-121.795922°	-121.776942°
DWR ID	DWR_RD2060_02_s_2017_2				
Comment Code					
FE : Fence					
Inspector Comment					
This fence has no permit.

Barbed wire fence on waterside has no permit.

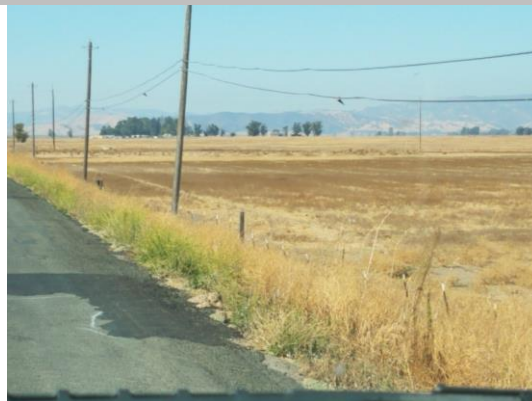
Photo 1 of 1 : FA_2018_RD2060_242_7_20181025_00011.jpg

LM Start	0.83	Rating **	M	Issue No.	7
LM End	1.14	Issue Type +	Ma	Location *	WS
Category	Earthen Levee			GPS Latitude/Longitude	
				Start	End
Item	Vegetation			38.285145°	38.285110°
				-121.793728°	-121.787957°
DWR ID	DWR_RD2060_02_f_2018_7				
Comment Code					
V1 : Control annual grass and weeds on the levee slopes and easements.					
Inspector Comment					
Maintain vegetation on water side slope

View of vegetation on water side slope (October 2018)

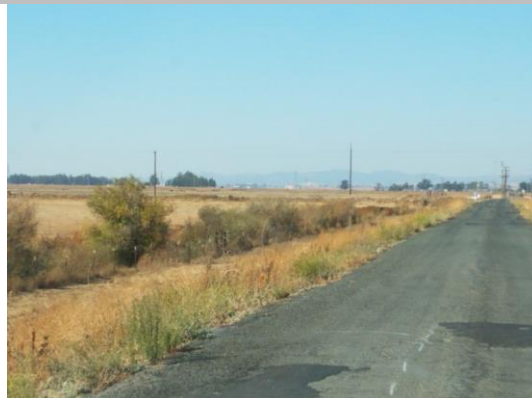
Photo 1 of 1 : FA_2018_RD2060_242_6_20181025_00012.jpg

LM Start	0.83	Rating **	M	Issue No.	6
LM End	1.73	Issue Type +	Ma	Location *	LS
Category	Earthen Levee			GPS Latitude/Longitude	
				Start	End
Item	Vegetation			38.285145 °	38.285143 °
				-121.793728 °	-121.777128 °
DWR ID	DWR_RD2060_02_f_2018_6				
Comment Code					
V1 : Control annual grass and weeds on the levee slopes and easements.					
Inspector Comment					
Maintain vegetation on land side slope

View of vegetation on land side slope (October 2018)

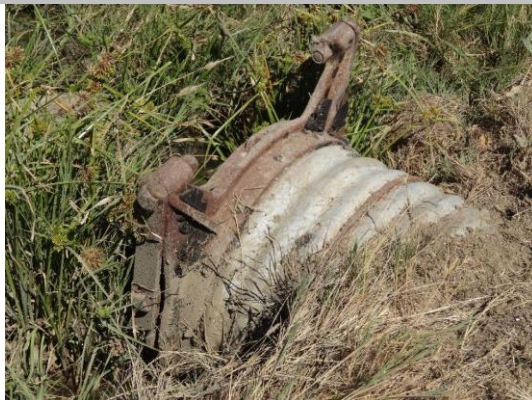
Photo 2 of 3 : UCIP_FA_2018_18386_30872.jpg

Comment Code						
Inspector Comment						
FS_ID:18386						
DS_ID:22056						
EP_NO: 10148						
Repair Type: Non-Urgent						
Crossing Status: Found						
UCIP Comments: U-type concrete headwall on LS. Not accessible due to fence.Vegetation is partially blocking inlet & outlet pipe.						
FIELD_STRUCT_DESC: 24-inch corrugated metal gravity drainage pipe through the levee, 16 feet below the crown. Flap gate on the waterside (WS) end. Concrete U-shaped headwall on the landside (LS) end. Not accessible due to a fence. Vegetation is partially blocking the inlet and the outlet of the pipe. (24-inch drainage pipe through the levee and a flap gate retained under Automatic Board Order (ABO) issued as Permit No. 10148, 1974 - Reclamation District No. 2060, care of G. T. Wyatt).						
[Additional Reference(s): DWR Levee Log, 2005].						
FS Date: 8/15/2013

WS view: CM pipe with flap gate. Not accessible. Vegetation is partially blocking outlet pipe.

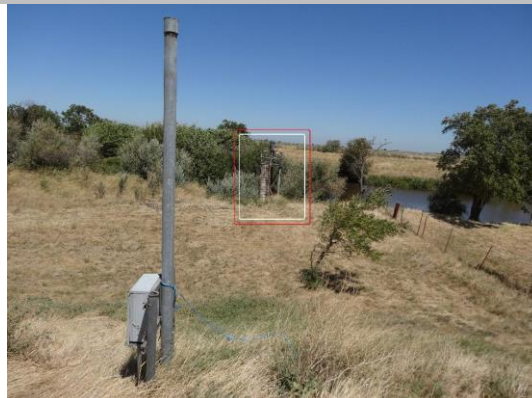
Photo 1 of 3 : UCIP_FA_2018_41668_31161.jpg

Comment Code						
Inspector Comment						
FS_ID:41668 DS_ID:22060 EP_NO: 5927 Repair Type: Non-Urgent Crossing Status: Found UCIP Comments: verify pipe has been abandoned properly. - abandoned pump and pipe.- electrical box on WS shoulder. FIELD_STRUCT_DESC: *ABANDONED* 18-inch steel irrigation discharge pipe through the levee, 4 feet below the crown. Corrugated metal cutoff wall. Pump on a piling structure on the riverbank. Siphon breaker on the landside (LS) slope. Concrete distribution box and irrigation ditch at the LS toe. (To relocate an existing irrigation pumping plant and discharge pipe through the levee authorized under Permit No. 5927, 1967 - Cache Slough Pheasant Hunting Preserve, Inc., care of Downey, Brand, Seymour, and Rohwer, Attorneys at Law). [Additional Reference(s): DWR Levee Log, 2005]. FS Date: 8/15/2013

WS view: electrical box on pole and pump structure in background.

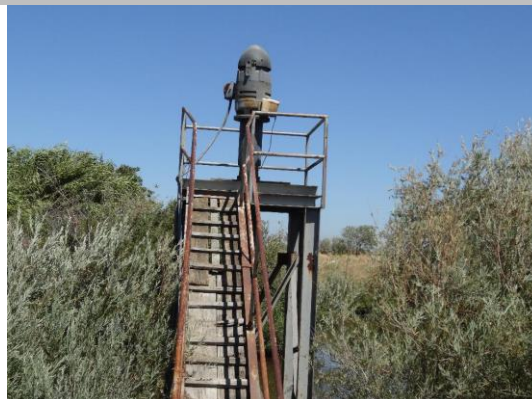
Photo 2 of 3 : UCIP_FA_2018_41668_31160.jpg

WS view: pump on pile structure with stairs on bank.

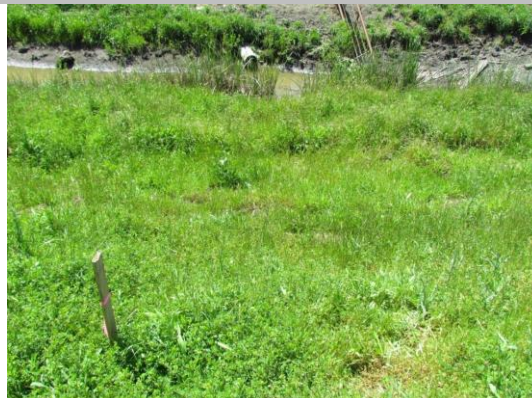
Photo 1 of 2 : FA_2018_RD2060_243_16_20180925_00007.jpg

LM Start	0.07	Rating **	M	Issue No.	16
LM End	0.07	Issue Type +	Ma	Location *	LS
Category	Earthen Levee			GPS Latitude/Longitude	
				Start	End
Item	Slope Stability			38.296350 °	38.296302 °
				-121.747642 °	-121.747565 °
DWR ID	DWR_RD2060_03_s_2017_16				
Comment Code					
S1 : Repair slope instability.					
Inspector Comment					
Sloughing on LS slope.

Looking down from the shoulder at the sloughing in the slope towards the irrigation ditch at toe.

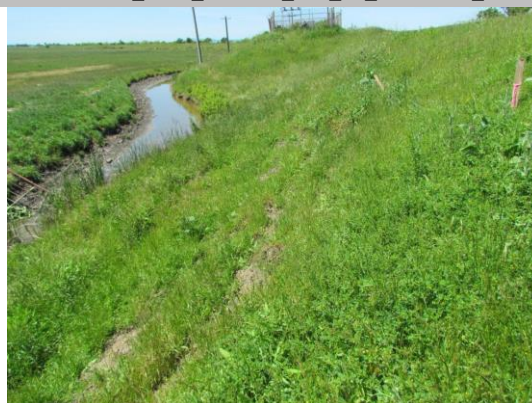
Photo 2 of 2 : FA_2018_RD2060_243_16_20180925_00008.jpg

Standing on the slope looking upstream at the slough.

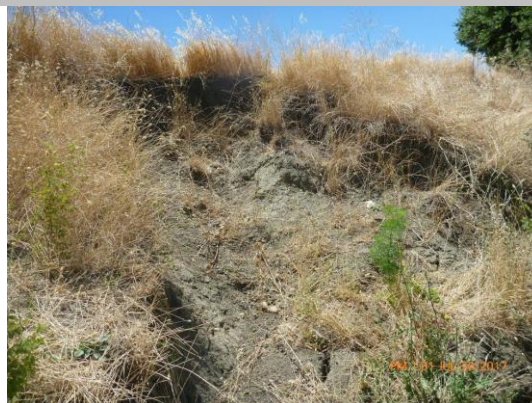
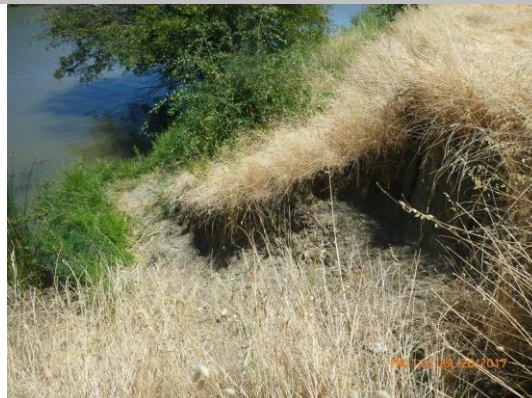
LM Start	0.64	Rating **	M	Issue No.	14
LM End	0.64	Issue Type +	Ma	Location *	
Category	Supplemental			GPS Latitude/Longitude	
				Start	End
Item	2017 Storm Damage			38.292197°	38.292208°
				-121.739661°	-121.739611°
DWR ID	DWR_RD2060_03_f_2017_14				
Comment Code					
Inspector Comment					
Levee Evaluation Comments					
Description:Erosion commences near the edge of the crown and extends down the slope. Erosion has resulted in slippage into the waterside toe.					
Site ID No:386					
Site Designation:LMA-213					
Repair Type: Erosion					
Rating:Area of Concern					
Field Date:7/20/2017					
Notes:

LM Start	0.64	Rating **	M	Issue No.	14 (cont)	
LM End	0.64	Issue Type +	Ma	Location *		
Category	Supplemental			GPS Latitude/Longitude		
				Start	End	
Item	2017 Storm Damage			38.292197 °	38.292208 °	
				-121.739661 °	-121.739611 °	
DWR ID	DWR_RD2060_03_f_2017_14					
Comment Code						
Inspector Comment						
Levee Evaluation Comments						
Description:Erosion commences near the edge of the crown and extends down the slope. Erosion has resulted in slippage into the waterside toe.						
Site ID No:386						
Site Designation:LMA-213						
Repair Type: Erosion						
Rating:Area of Concern						
Field Date:7/20/2017						
Notes:

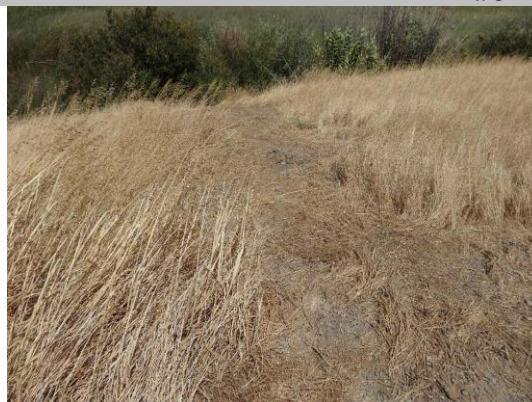
Photo 1 of 2 : UCIP_FA_2018_18727_31317.jpg

LM Start	0.90	Rating **	M	Issue No.	72							
LM End	0.90	Issue Type +	En	Location *								
Category	Supplemental		GPS Latitude/Longitude									
			Start	End								
Item	DWR UCIP Field Study		38.290684 °	38.290684 °								
			-121.735668 °	-121.735668 °								
DWR ID	22067											
Comment Code												
Inspector Comment												
FS_ID: 18727 DS_ID: 22067 EP_NO: N/A Repair Type: Non-Urgent Crossing Status: Found UCIP Comments: Seem abandoned. Not found- pump on LS. Needs more exploration. FIELD_STRUCT_DESC: 6-inch steel irrigation discharge pipe through the levee, 2.8 feet below the crown. Pump on the landside (LS). Gate valve on the waterside (WS). [Additional Reference(s): USACE Sacramento O&M Manual 107, April 1959, (HLM 0.4), 10-inch pipe referenced]. FS Date: 8/15/2013

Waterside view: levee slope.

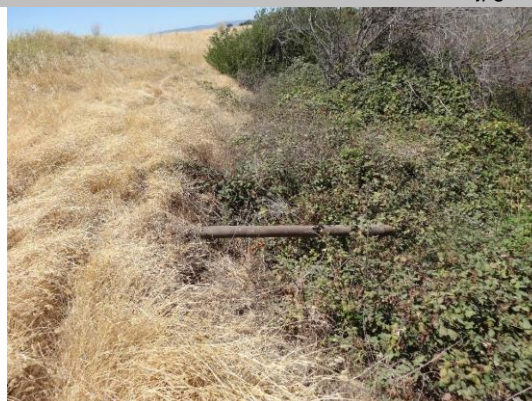
Photo 2 of 2 : UCIP_FA_2018_18727_31316.jpg

LM Start	0.90	Rating **	M	Issue No.	72 (cont)	
LM End	0.90	Issue Type +	En	Location *		
Category	Supplemental			GPS Latitude/Longitude		
				Start	End	
Item	DWR UCIP Field Study			38.290684 °	38.290684 °	
				-121.735668 °	-121.735668 °	
DWR ID	22067					
Comment Code						
Inspector Comment						
FS_ID:18727 DS_ID:22067 EP_NO: N/A Repair Type: Non-Urgent Crossing Status: Found UCIP Comments: Seem abandoned.Not found- pump on LS. Needs more exploration. FIELD_STRUCT_DESC: 6-inch steel irrigation discharge pipe through the levee, 2.8 feet below the crown. Pump on the landside (LS). Gate valve on the waterside (WS). [Additional Reference(s): USACE Sacramento O&M Manual 107, April 1959, (HLM 0.4), 10-inch pipe referenced]. FS Date: 8/15/2013

Waterside view: levee slope and a steel pipe.

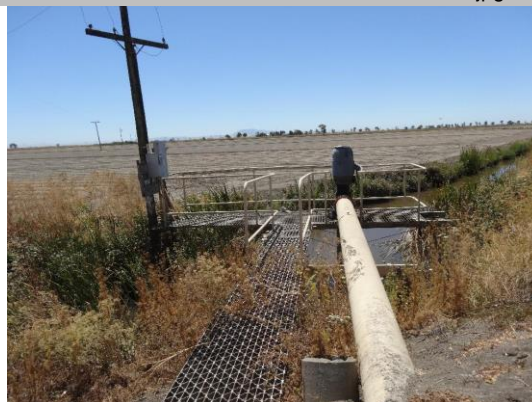
Photo 1 of 3 : UCIP_FA_2018_18726_31314.jpg

Comment Code					
Inspector Comment					
FS_ID:18726 DS_ID:22063 EP_NO: 6342 Repair Type: Non-Urgent Crossing Status: Found UCIP Comments: Leaky siphon breaker may need to be repaired. Dense vegetation on WS.Not found- gate valve on LS. FIELD_STRUCT_DESC: 16-inch coated steel drainage discharge pipe through the levee, 8 feet below the crown. Vertical pump in drainage ditch on the landside (LS). Gate valve on the LS. Siphon breaker on the waterside (WS). (Plans to replace a 10-inch drainage pipe through the levee authorized under Permit No. 6342, 1968 - Hastings Farms. Plans to revise plans by changing pipe size from 10-inch to 16-inch through the levee authorized under Permit No. 6342-A, 1971 - Hastings Farms). FS Date: 8/15/2013

Landside view: pump, service pole, steel support structure, walkway, and pipe.

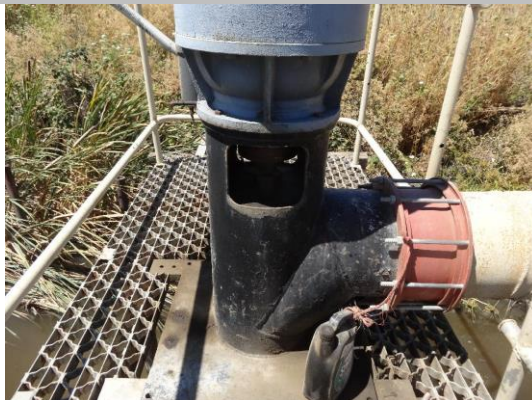
Photo 2 of 3 : UCIP_FA_2018_18726_31313.jpg

Comment Code						
Inspector Comment						
FS_ID:18726 DS_ID:22063 EP_NO: 6342 Repair Type: Non-Urgent Crossing Status: Found UCIP Comments: Leaky siphon breaker may need to be repaired. Dense vegetation on WS.Not found- gate valve on LS. FIELD_STRUCT_DESC: 16-inch coated steel drainage discharge pipe through the levee, 8 feet below the crown. Vertical pump in drainage ditch on the landside (LS). Gate valve on the LS. Siphon breaker on the waterside (WS). (Plans to replace a 10-inch drainage pipe through the levee authorized under Permit No. 6342, 1968 - Hastings Farms. Plans to revise plans by changing pipe size from 10-inch to 16-inch through the levee authorized under Permit No. 6342-A, 1971 - Hastings Farms). FS Date: 8/15/2013

Landside view: pipe and pump on steel structure in drain ditch.

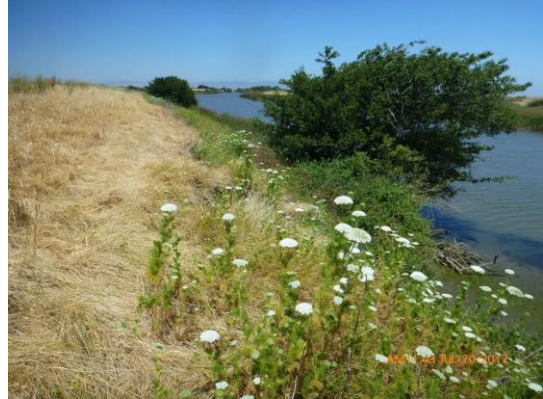
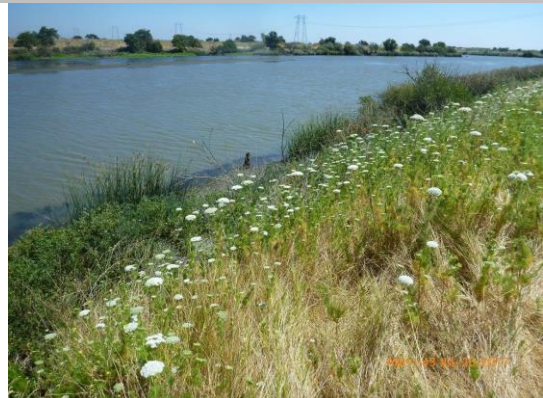
LM Start	1.21	Rating **	M	Issue No.	20 (cont)	
LM End	1.23	Issue Type +	Ma	Location *		
Category	Supplemental			GPS Latitude/Longitude		
				Start	End	
Item	2017 Storm Damage			38.290511 °	38.290486 °	
				-121.729867 °	-121.729603 °	
DWR ID	DWR_RD2060_03_f _ 2017_20					
Comment Code						
Inspector Comment						
Levee Evaluation Comments						
Description:Erosion commences 1/4 of the way down the slope with slippage towards the water side toe.						
Site ID No:390						
Site Designation:LMA-217						
Repair Type: Erosion						
Rating:Area of Concern						
Field Date:7/20/2017						
Notes: Erosion halfway down WS slope. Monitor for progression.

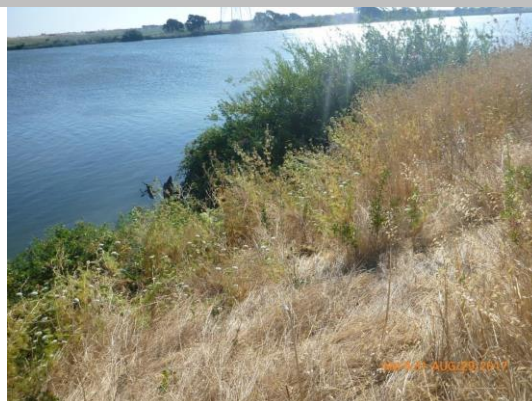
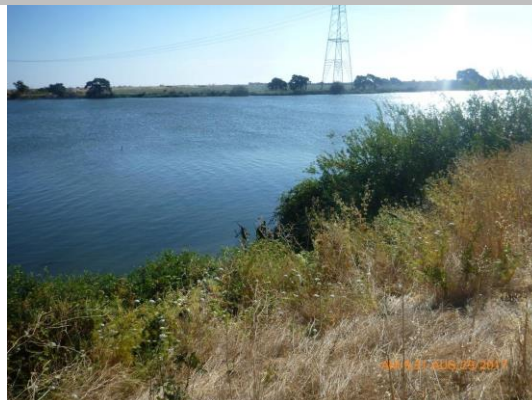
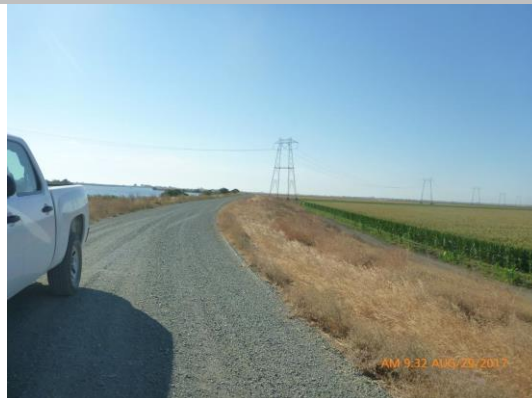
LM Start	1.38	Rating **	M	Issue No.	21
LM End	1.42	Issue Type +	Ma	Location *	
Category	Supplemental			GPS Latitude/Longitude	
				Start	End
Item	2017 Storm Damage			38.290067°	38.289608°
				-121.726839°	-121.726344°
DWR ID	DWR_RD2060_03_f_2017_21				
Comment Code					
Inspector Comment					
Levee Evaluation Comments					
Description:MBK Delta Erosion Sites_6-29-2017					
Site ID No:482					
Site Designation:LMA-320					
Repair Type: Erosion					
Rating:Area of Concern					
Field Date:8/29/2017					
Notes:

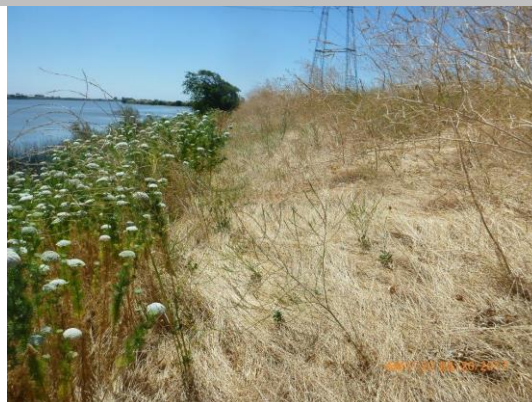
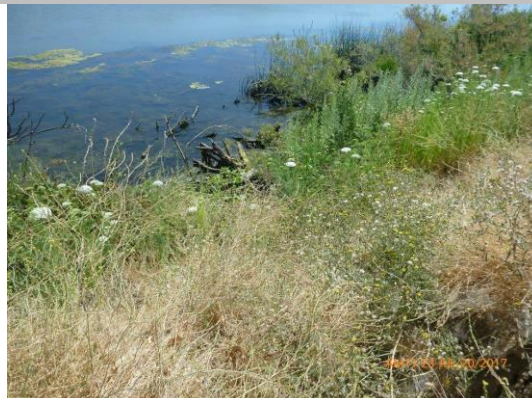
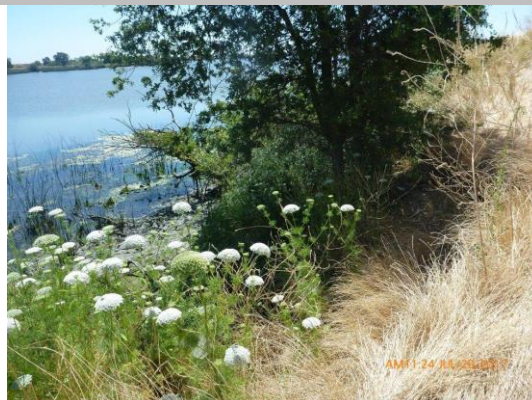
LM Start	1.45	Rating **	M	Issue No.	22
LM End	1.59	Issue Type +	Ma	Location *	
Category	Supplemental			GPS Latitude/Longitude	
				Start	End
Item	2017 Storm Damage			38.289256 °	38.287689 °
				-121.726050 °	-121.724658 °
DWR ID	DWR_RD2060_03_f _ 2017_22				
Comment Code					
Inspector Comment					
Levee Evaluation Comments					
Description:Erosion commences halfway down the slope and results in slippage into the waterside toe.					
Site ID No:392					
Site Designation:LMA-219					
Repair Type: Erosion					
Rating:Area of Concern					
Field Date:7/20/2017					
Notes: Moderate erosion present on WS slope. Monitor for progression.

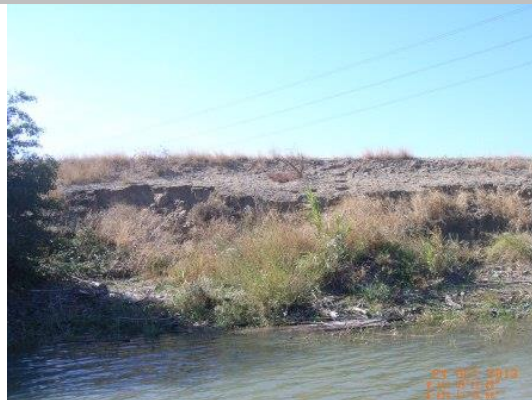
Photo 1 of 1 : FA_2018_RD2060_243_7_20181105_00091.jpg

LM Start	1.52	Rating **	A/W	Issue No.	7
LM End	1.74	Issue Type +	Ma	Location *	WS
Category	Supplemental			GPS Latitude/Longitude	
				Start	End
Item	2017 USACE Erosion Survey, DRAFT			38.288598 °	38.286051 °
				-121.725184 °	-121.722818 °
DWR ID	DWR_RD2060_03_f_2018_7				
Comment Code					
Inspector Comment					
2017 Site ID: CHS 23.6 R					
Status: Eroding					
2017 Field Notes: No observed changes.					
Site History: Site added in 1997 and removed in 2003. 2005 - Put back in the inventory. 2006 - Stone repair at the middle of the site. 2011 - Some rock place at toe in the past year. 2013 - Site extended both upstream and downstream to include new erosion pockets.

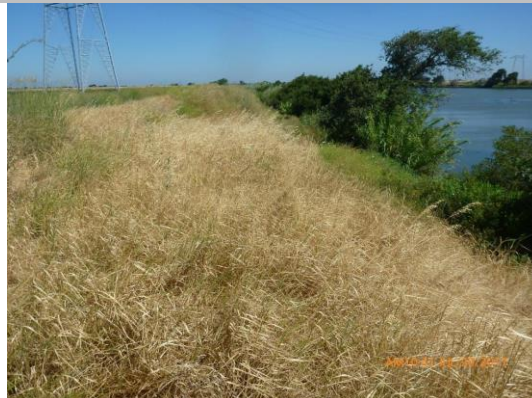
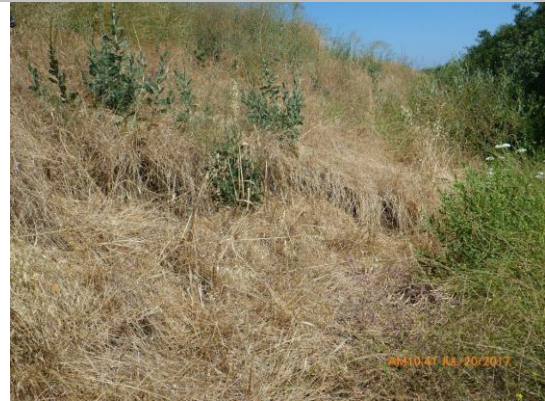
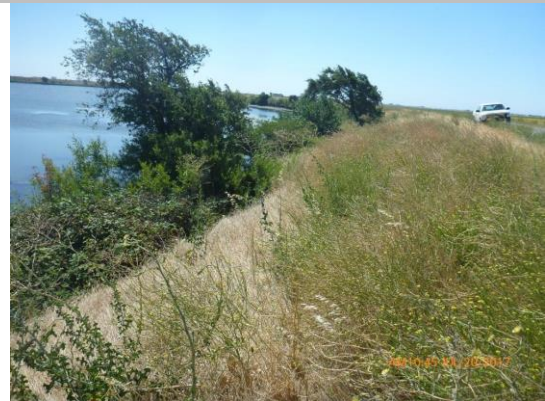
LM Start	1.62	Rating **	A/W	Issue No.	23
LM End	1.63	Issue Type +	Ma	Location *	
Category	Supplemental			GPS Latitude/Longitude	
				Start	End
Item	2017 Storm Damage			38.287336 °	38.287222 °
				-121.724364 °	-121.724253 °
DWR ID	DWR_RD2060_03_f_2017_23				
Comment Code					
Inspector Comment					
Levee Evaluation Comments					
Description:Erosion commences halfway down the slope and results in slippage into the waterside toe. Existing rip rap has sloughed into the water side toe.					
Site ID No:393					
Site Designation:LMA-220					
Repair Type: Erosion					
Rating:Serious					
Field Date:7/20/2017					
Notes: Moderate sloughing 8ft from WS crown. Erosion at high water mark.

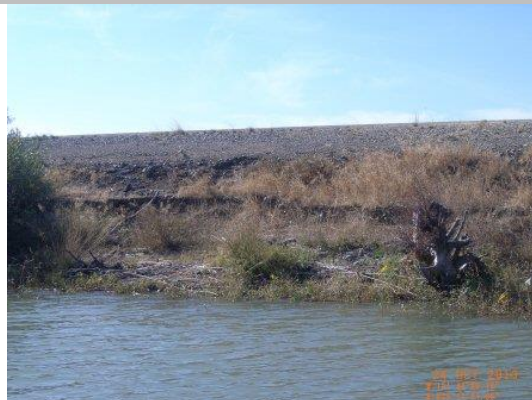
Photo 1 of 1 : FA_2018_RD2060_243_6_20181105_00090.jpg

LM Start	2.02	Rating **	M	Issue No.	6
LM End	2.08	Issue Type +	Ma	Location *	WS
Category	Supplemental			GPS Latitude/Longitude	
				Start	End
Item	2017 USACE Erosion Survey, DRAFT			38.284105 °	38.283302 °
				-121.718471 °	-121.717814 °
DWR ID	DWR_RD2060_03_f_2018_6				
Comment Code					
Inspector Comment					
2017 Site ID: CHS 23.0 R					
Status: Eroding					
2017 Field Notes: No observed changes.					
Site History: 2010 - Small maintenance site.

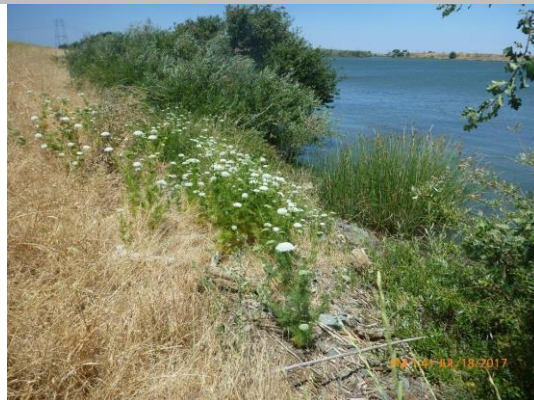
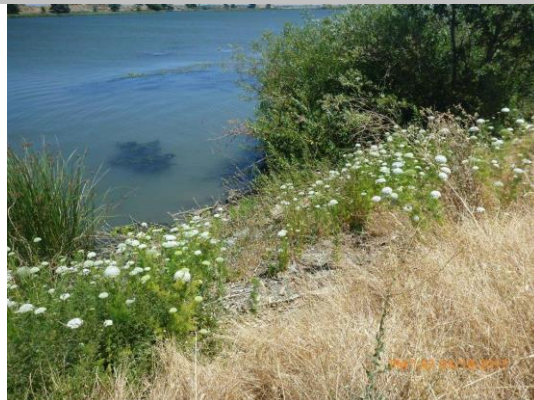
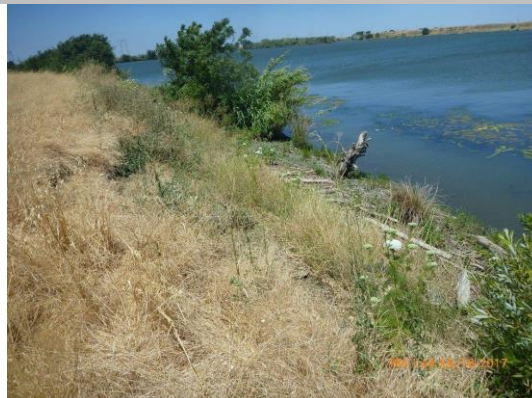
LM Start	2.02	Rating **	M	Issue No.	26
LM End	2.06	Issue Type +	Ma	Location *	
Category	Supplemental			GPS Latitude/Longitude	
				Start	End
Item	2017 Storm Damage			38.283914 °	38.283422 °
				-121.718614 °	-121.718206 °
DWR ID	DWR_RD2060_03_f_2017_26				
Comment Code					
Inspector Comment					
Levee Evaluation Comments					
Description:Erosion commences halfway down the slope and results in slippage into the waterside toe. Existing rip rap has sloughed into the water side toe.					
Site ID No:396					
Site Designation:LMA-223					
Repair Type: Erosion					
Rating:Area of Concern					
Field Date:7/18/2017					
Notes: Erosion to high water line.
